# Manhole Inspection Summary

Manhole # S05SS1010MH

Insp Date: **9/12/06 9:14 AM**

**Location** Address: **3408 W ROGERS AVE**

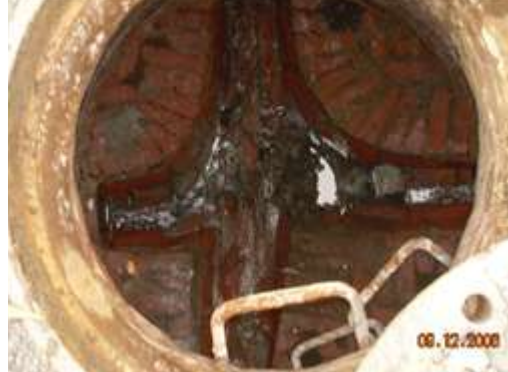
Top View

Frame leaks. Adjustment deterioration and infiltration. Barrel infiltration. Channel debris.

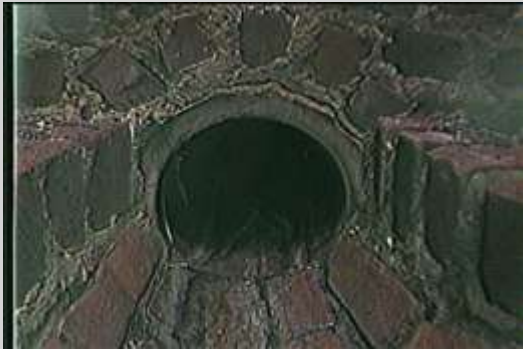
### 8 in. Circular Gravity Sewer Pipe Out @ 12 O'Clock

Barrel and Channel deterioration.

Infiltration: **None** Pipe Seal Cond: **Unknown**

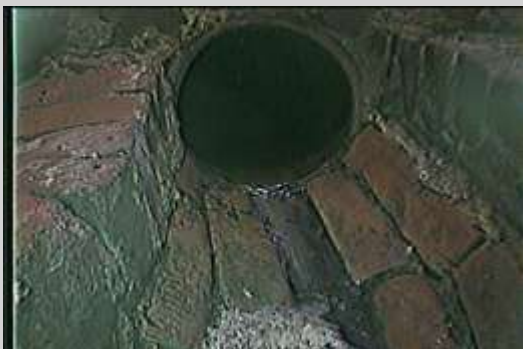
### 8 in. Circular Gravity Sewer Pipe In @ 3 O'Clock

Channel deterioration.

Infiltration: **Evidence** Pipe Seal Cond: **Cracked**

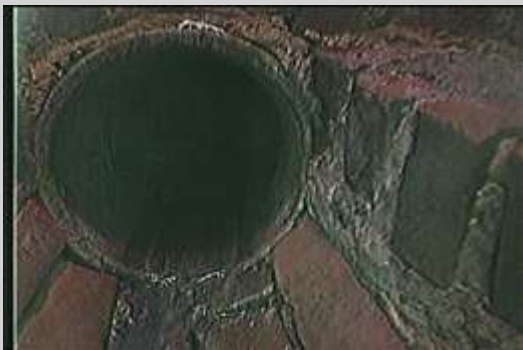
Pipe In @ 9 O'Clock

Infiltration: **Evidence** Pipe Seal Cond: **Unknown**
